CAPE TOWN WATER AND SANITATION DESIGN

A Major Qualifying Project Proposal

1. Water
2. Sanitation
3. Monwabisi Park

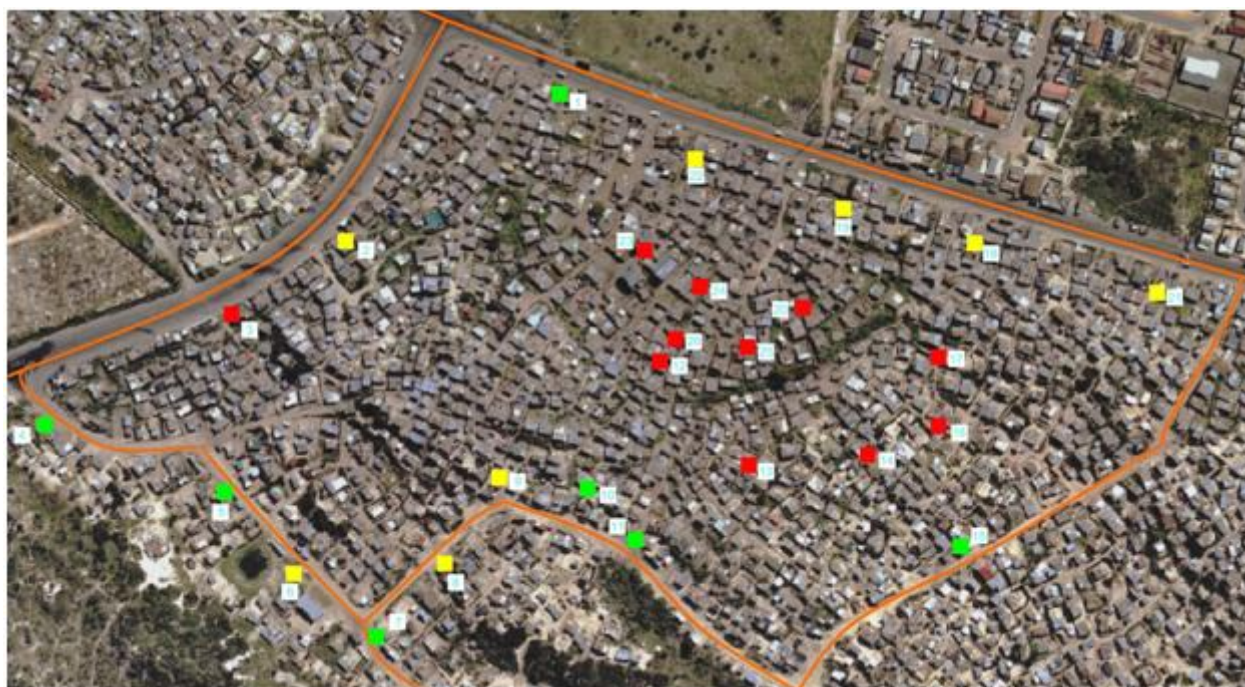
Figure 8: Location and Condition of Water Taps in C Section
(Granfone *et al.*, 2008)

Currently in C Section there are 27 water taps, seven of which are fully functional and eleven that are not functioning. The remaining nine taps possess problems such as missing handles and nozzles, broken piping, and leaks. As shown in Figure 8, the taps in better condition (shown in green) are located along the main roads surrounding C Section, whereas the taps in the center of the settlement are in poor condition (shown in red). The taps along the road are in better physical condition because of their close proximity to pour-flush toilets, which are more frequently maintained by the city. The residents also assist in the maintenance of the taps because without water their toilets do not function (Granfone *et al.*, 2008).

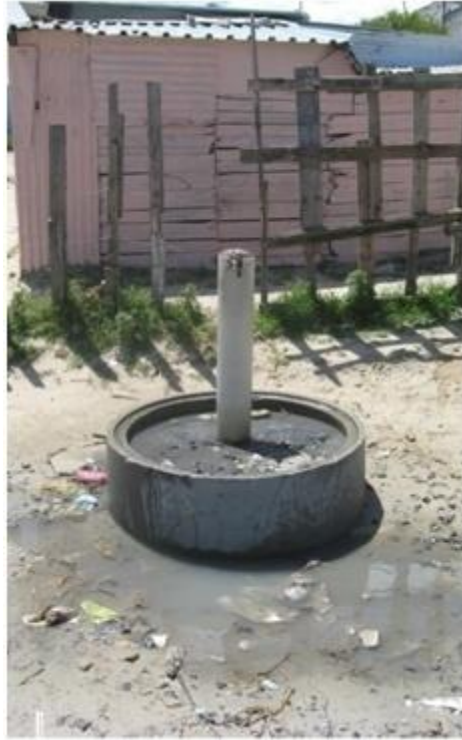
Figure 10: Standing Water at a Water Tap in C Section (Granfone *et al.*, 2008)

Poor drainage is major issue because it results in standing water, which directly affects the health of the community. As mentioned above, the water taps are installed above a cement cylinder intended to aid in proper drainage. The cylinder is filled with stone to allow for more rapid drainage into the ground. However, due to misunderstanding of the residents, these drainage cylinders get clogged with trash, food scraps, and sand. The failure of the drainage cylinder results in standing water in and around the taps, which becomes an area of high contamination as explained in Section 3.3. Additionally, food scraps are left in the cylinders, which attract flies and promote the growth of bacteria (Granfone *et al.*, 2008). Figure 10 is a picture of a tap in C Section surrounded by standing water.

The City of Cape Town attempted to facilitate drainage by installing irrigation systems next to the taps. However, these irrigation systems failed because fats and oils from dishwashing clogged the irrigation pipes.

Residents have also made failed attempts to eliminate standing water in the drainage cylinders. For example, residents have punctured holes in the drainage cylinders allowing water to drain out of the bottom preventing it from pooling at the top. However, this caused the water to flow into one area next to the cylinder, which also had poor drainage and caused erosion. Additionally, the constant overflow wears away the surrounding landscape causing damage to roads (Granfone *et al.*, 2008).

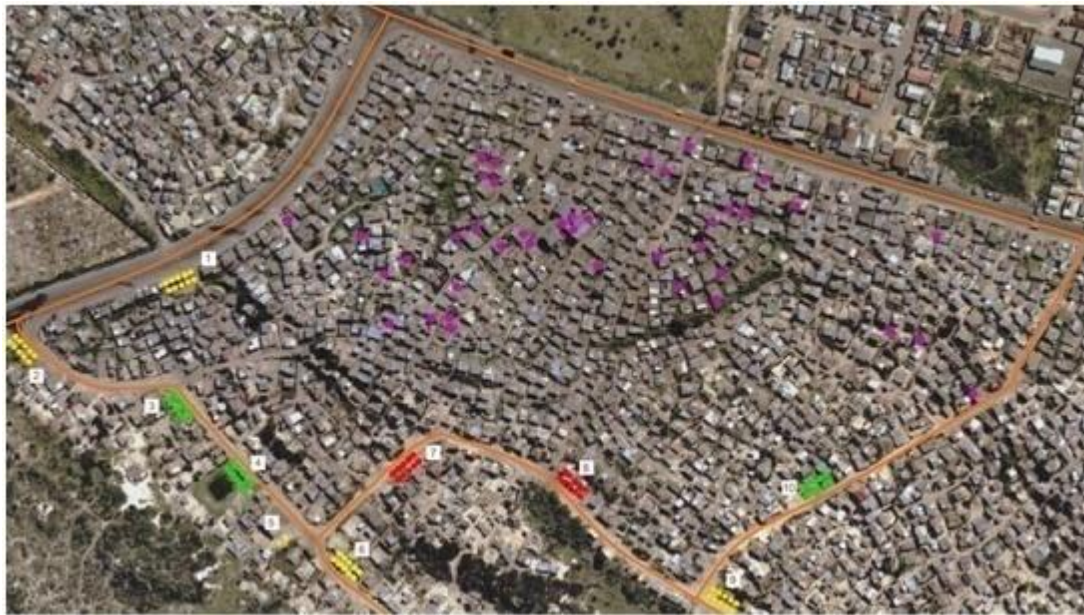
Figure 12: Sanitation Services in C Section (Granfone *et al.*, 2008)

Figure 12 illustrates the distribution of sanitation facilities across C Section in Monwabisi Park. The green markers indicate toilets in good condition, the yellow markers show toilets in fair condition, the red markers indicate pour-flush toilets in poor condition and the purple markers indicate pit latrines.

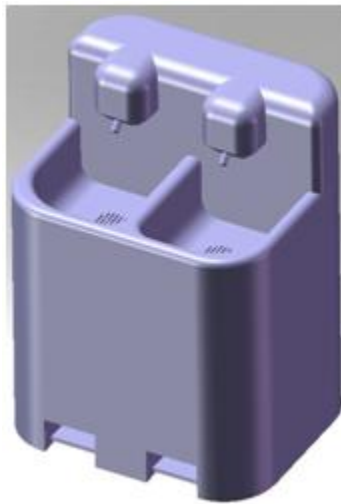
Figure 15: Proposed Hand Washing Station (Granfone *et al.*, 2008)

Public sinks would be part of the facility as well. Granfone *et al.* (2008) recommended the sinks use water primarily from rainwater collection tanks. Although the rainwater collection tanks are unlikely to supply sufficient water for full-time use, the strategy conserves water and reduces the demand on the municipal water system. Public sinks should encourage hand washing, especially if soap is provided. This would hopefully decrease the transmission of disease around the facility. Walking paths would lead people past the sinks as they exit the facility to further encourage hand washing. A sample hand washing station is shown in Figure 15.

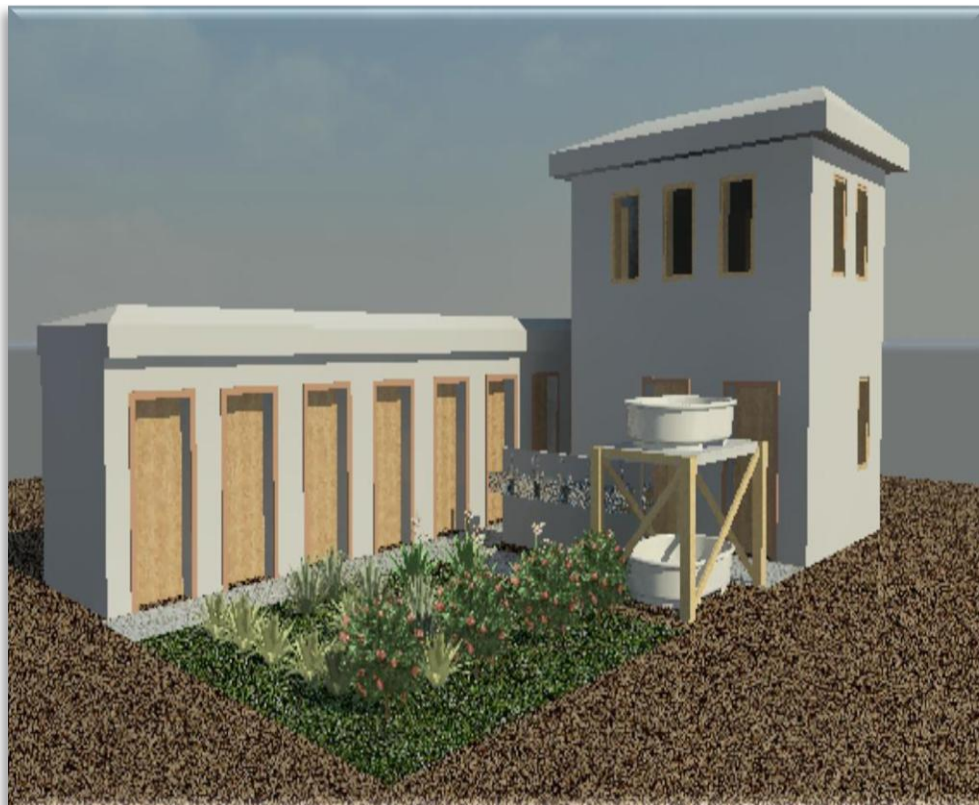
Figure 26: Facility Variation

It is understood that not all areas in C Section would have the same design needs as the Indlovu Center site. One constraint driving the design of any facility is sun exposure. The Enviro Loo toilets should always be placed in the area of the lot that is facing north. Another constraint for the facility is space. Figure 26 shows a 3-dimentional rendering of the facility. Because excess space is unavailable, the facility is compact and thus changes to the design are limited.
